KCE STRUCTURAL ENGINEERS, P.C.

RE: Westfield Montgomery Mall Westlake Garage
Gridlines 14 and 15 and C and D
Partial Precast Tee Collapse
Cause and Effect

Job No. 2013-10

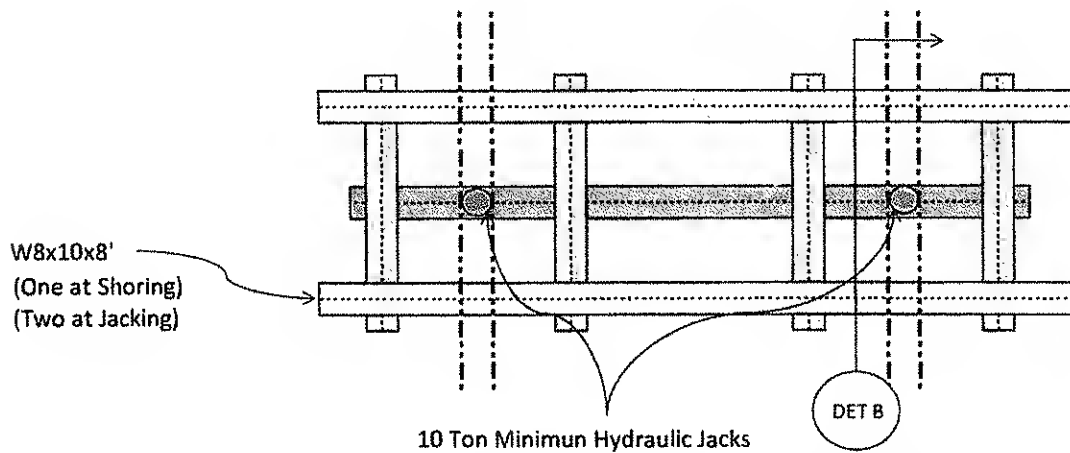
DETAIL A - JACKING TOWER RIG DETAIL

The transverse W8x31's were placed snug to the bottom of the stem of the double tee and the double tee was jacked from the longitudinal W8x31 Jacking beam, shown in orange.

Figure 2 - WT Drawing Sheet J3 dated 05-05-13: "Jacking" Tower Configuration
(Color added by KCE.)

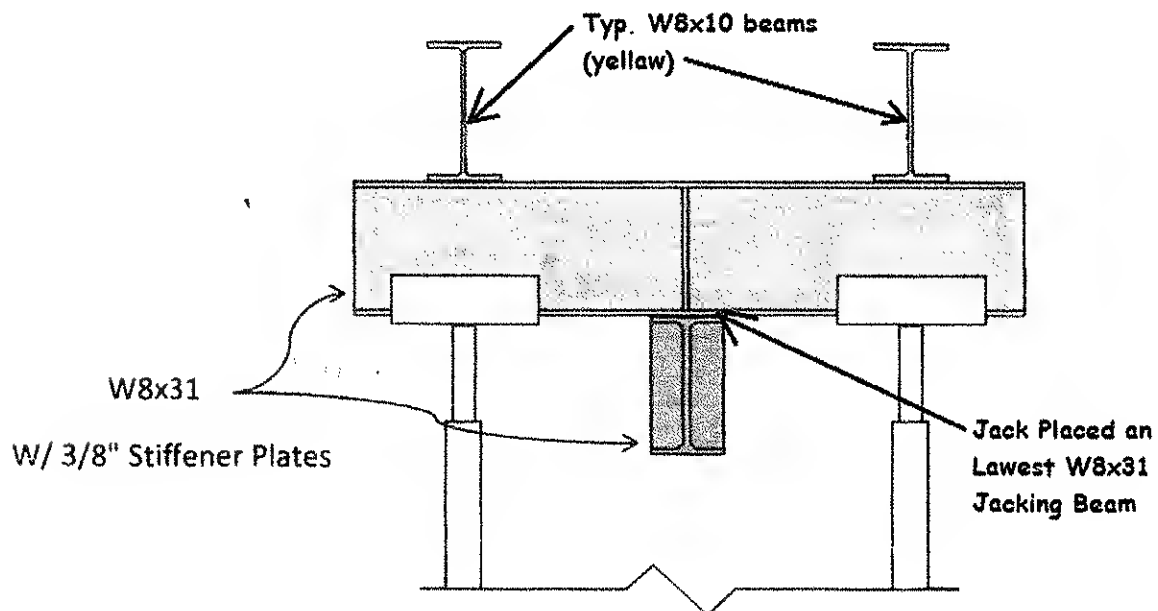
DETAIL B - JACKING FRAME SECTION

Figure 3 - WT Drawing Sheet J3 dated 05-05-13: Section of "Jacking" Tower Configuration
(Notes in bold and color added by KCE)

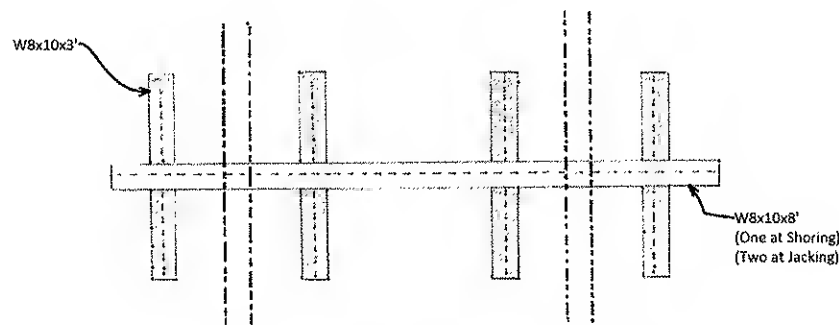
Figure 4 - Plan view of "Safety" Tower Configuration
(Sketch by KCE.)

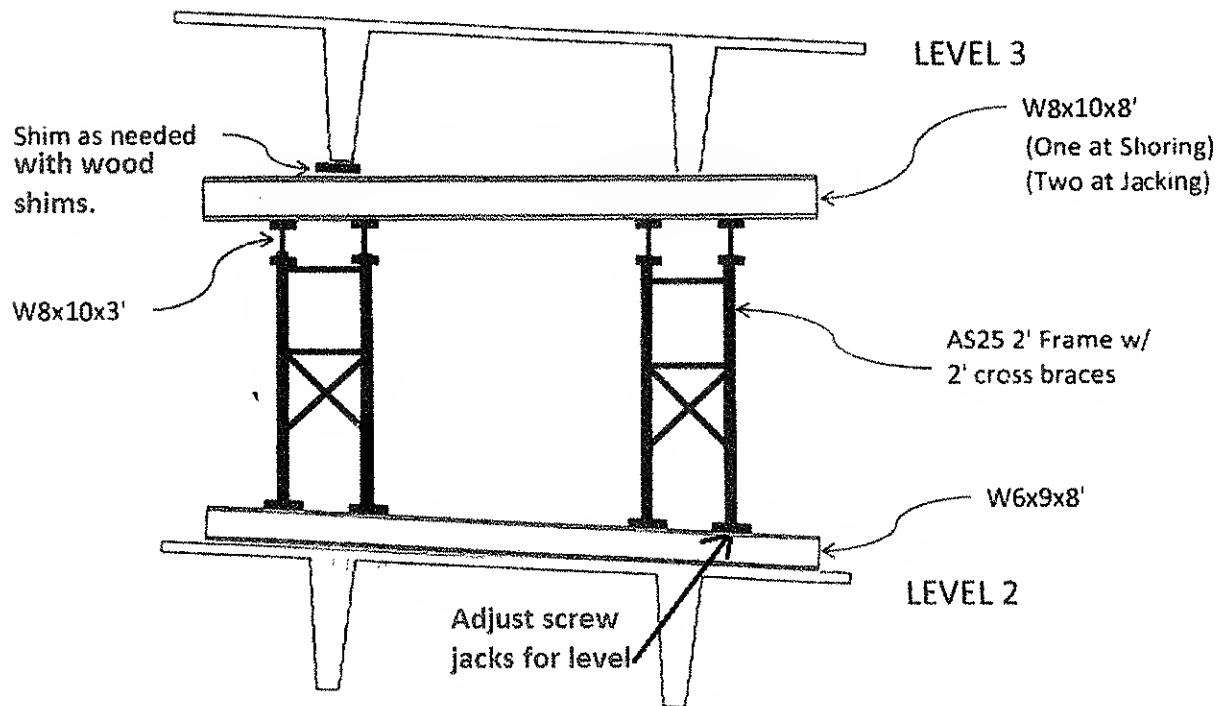
Figure 5 - WT Drawing Sheet J3 dated 05-05-13: Section of Safety Tower Configuration
(Notes in blue and color added by KCE.)

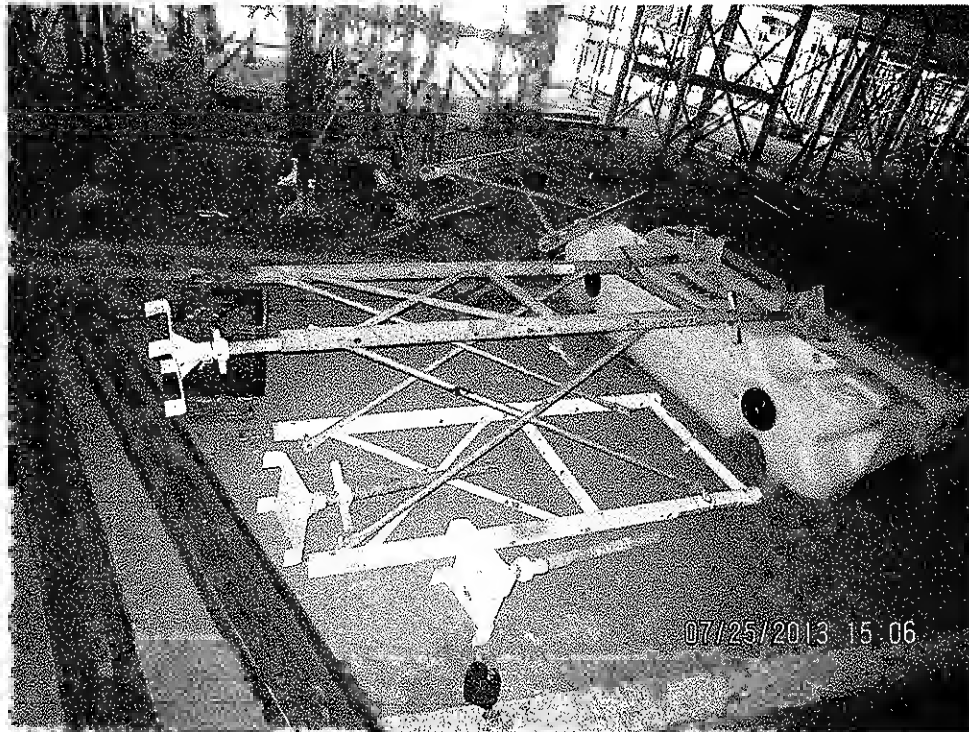
Picture 2 - North End "Jacking" Tower

The "jacking" tower arrangement is configured so the longitudinal (low) W8x31 beam is bolted to the transverse W8x31's beams, securing its location. It is not likely that the load being applied to the transverse beams would be eccentric. Therefore, for our evaluation, we used a load on the transverse W8x31s equally distributed to the supporting legs of the AS2S base frames.

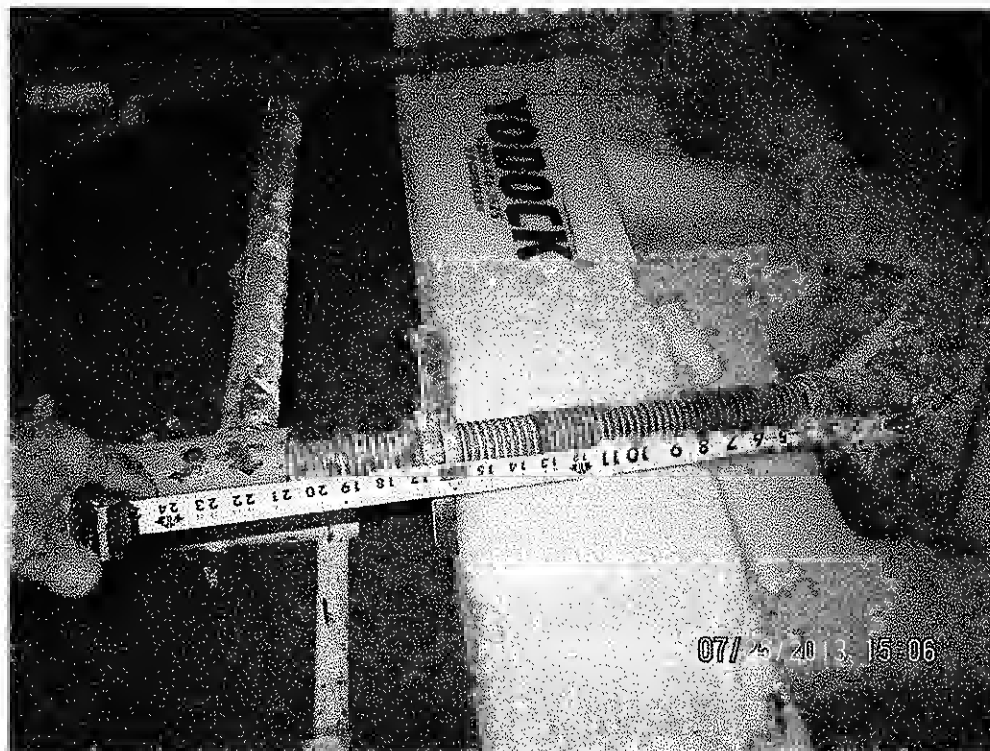
Picture 3 - Extension of "Jacking" Tower Frame Base > 12"

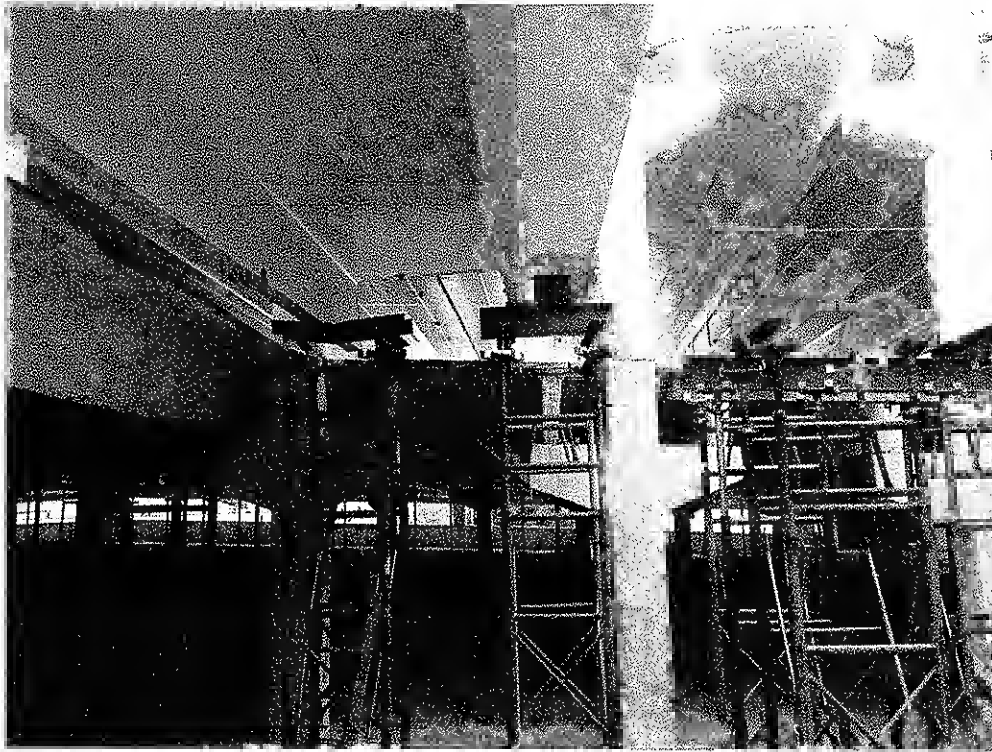
Based on the site photographs we took upon arrival, the as-designed shoring tower layout may not have been adhered to throughout. As can be seen in Picture 4 two smaller individual W8x10

beams are spanning the shoring towers in the longitudinal direction as opposed to the continuous 8' W8x10 spanning both 2'x2' Adjust-A-Shore® framing towers as shown on WT drawings J1-J5.

Picture 4 - North End "Safety" Towers of Partially Collapsed Tee

The "safety" towers under the partially collapsed tee were not installed per WT sheets J1-J5 dated 05/05/13 or sheets P1 and P2 dated 05/06/13. The continuous W8x31 jacking beam was not placed spanning the two "jacking" towers but rather two separate beams were used. (Having two separate longitudinal beams allows each individual 2'x2' A525 Adjust-A-Shore shoring tower to be moved and placed independently of each other and extended to different heights for construction adjustment.)

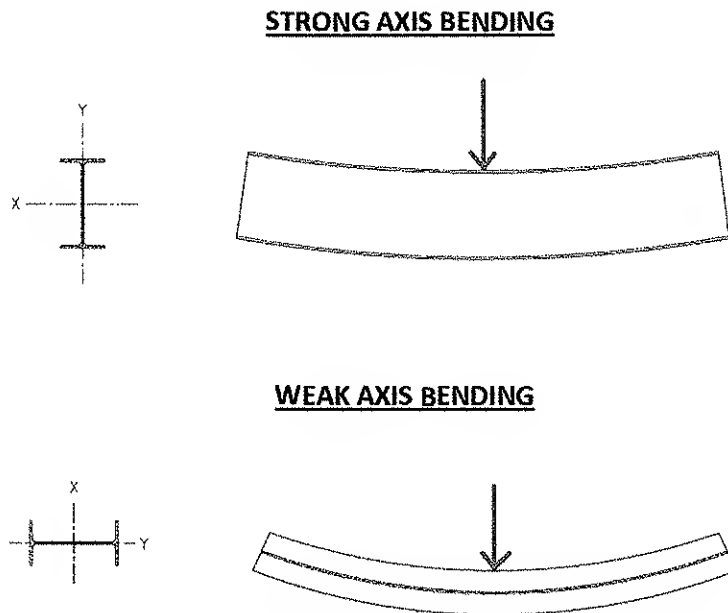
In the configuration shown on WT drawings J1-J5 the W8x10 and W8x31 beams on the "safety" and "jacking" towers have adequate strength to support the load of the precast double tee even if the entire load is concentrated in one location on the beam. This is true as long as the load is applied to the strong axis (Figure 6). As can be seen in Picture 4, where the longitudinal beam rotated, apparently during the collapse, bending will occur when load is applied to the weak axis (Figure 6).

Figure 6- Diagram of Strong and Weak Axis Beam Bending

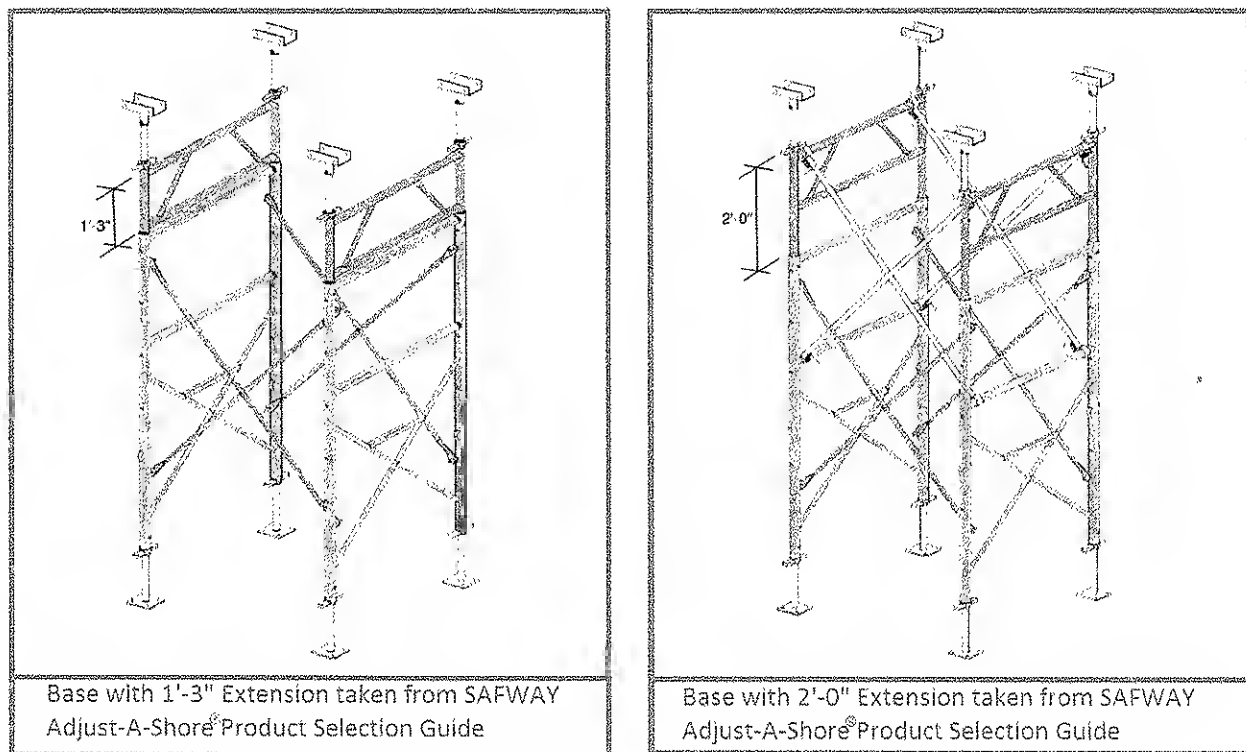
Figure 7 - SAFWAY Bracing Configurations for Extended Frames (colors added by KCE)

The SAFWAY Adjust-A-Shore® Product Selection Guide notes that AS24 extension frames can be used to extend the height of AS2S Base Frames. When the height of extension is 2' or greater additional diagonal gooser (cross) braces are needed (See Figure 7 above, which indicates the configuration of a 2' extension with the required gooser braces (shown in yellow)). It also indicates the configuration for a 1'-3" extension when no additional bracing is required. The towers on site have the AS24 extension frames. Additional extension of the "jacking" towers was accomplished with the screw jack extensions. The "safety" towers did, however, utilize the AS24 extension frames with a 2'-0 extension but no gooser bracing was installed.

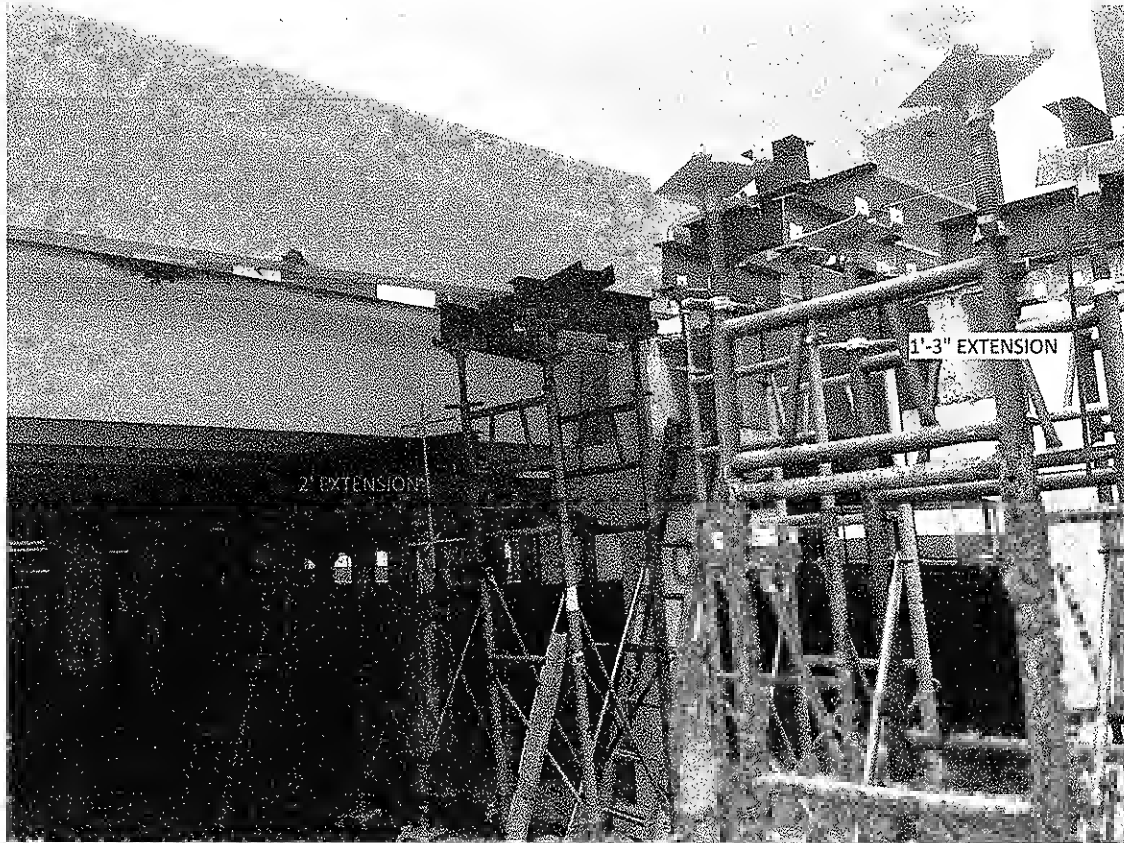
Picture 5 - Shoring Tower with Extension and no additional bracing

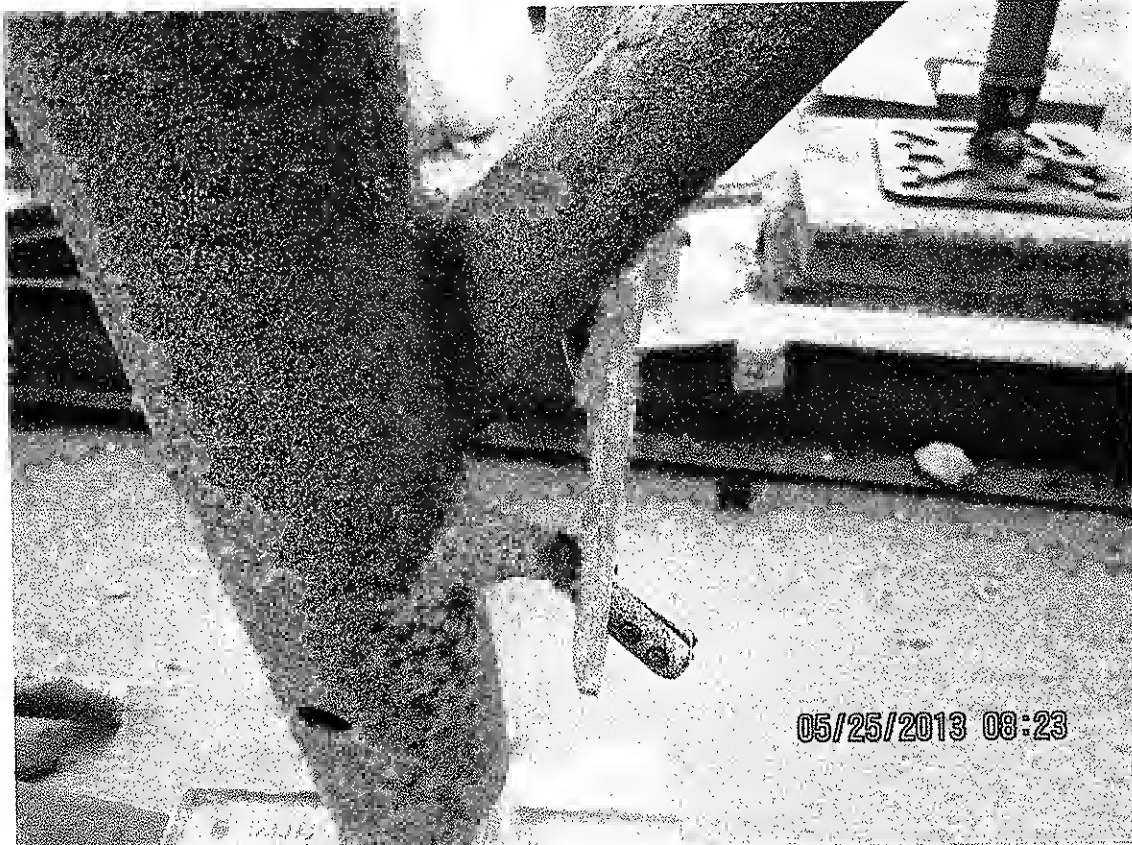
Whenever a load is applied at an angle to an element, the load is resolved into a vertical force and a horizontal force. If the tee was being jacked unevenly, it resulted in the tee being at an angle in the North-South direction, and, due to the ramp slope, in the East-West direction, a horizontal force would be introduced to the shoring towers. Without the bracing in the extension frames and no lateral bracing between the towers, additional movement is likely to occur and more force is likely to be introduced into the intra-tower cross bracing. It can be seen in many locations that the connection pins for the braces were in fact sheared and/or bent (Picture 6). The cross bracing buckled and the base tower legs split at the interface with the male extension section inside the female base tower leg.

Picture 6 - Connection pin of base frame
